COMET NUCLEUS TOUR

MISHAP INVESTIGATION BOARD REPORT May 31, 2003

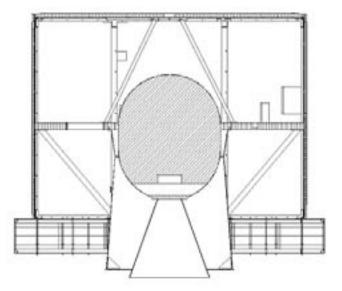
Figure 3. CONTOUR SRM configuration.

The CONTOUR Board concludes that the probable proximate cause for loss of the CONTOUR spacecraft was overheating of the forward-end of the spacecraft due to base heating from the SRM exhaust plume. The CON-TOUR SRM nozzle was embedded within the spacecraft to a greater degree than is typical (Fig. 3), and the resultant near-field effect of exhaust plume heating was not adequately accounted for in the design. Overheating may have caused substantial material weakening and structural degradation, which could have led to catastrophic dynamic instability. The deficiencies in the design process are discussed further in sections 5 and 6 of this report.

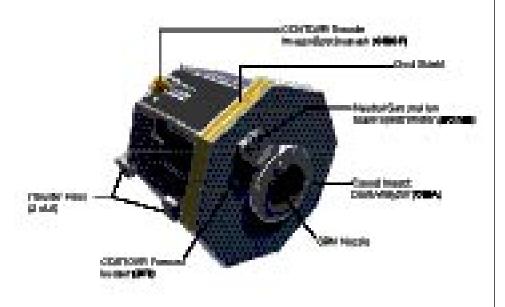
Figure 4. Forward end of the CONTOUR spacecraft.

The APL CONTOUR plume heating analysis³ assumed a worst-case combined radiative-convective plume heating environment of 50 suns (1 sun = 1358 W/m^2). The MIB commissioned multiple independent plume analysis efforts^{4,5,6,7} which indicated the heating was higher than APL had predicted. APL did not consider possible degradation in material surface properties⁸ due to plume contamination. This compounded the under-prediction of heating during the design phase. Changes in the surface absorptivity and emissivity because of plume impingement can significantly increase the effective radiative heat transfer from the plume in a given area.

It is beyond the scope of the MIB to analyze all the possible failure scenarios that could result from high localized heating of the forward end of the CONTOUR spacecraft. The MIB commissioned sufficient thermal analyses⁹ to conclude that some components such as the forward low-gain antenna are likely to have experienced temperatures high enough to melt the components.

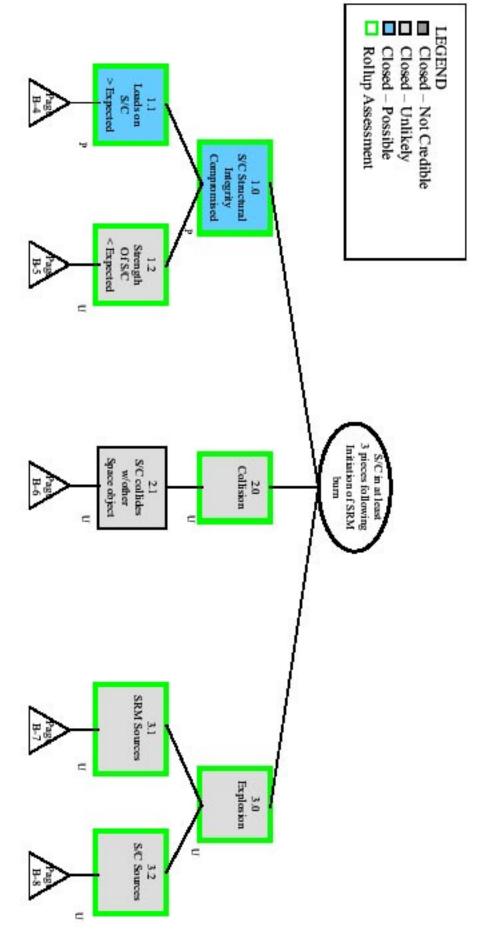
Figure B-1. CONTOUR fault tree diagram.

Following the initial information gathering meetings, the Board used Fault Tree Analysis to identify and analyze a broad range of possible failure scenarios, and to provide a systematic process to track possible causes to closure. Leads and sub-teams were assigned to the various fault tree branches/items based on areas of expertise. The leads documented and tracked the analysis and information gathering necessary to disposition each identified fault tree event. The CONTOUR MIB Fault Tree diagram is provided in Appendix B, the Fault Tree narrative is in Appendix C, and Fault Tree Closeout Records are in Appendix D.
