# X-RAY COMPUTED TOMOGRAPHY INSPECTION OF THE STARDUST HEAT SHIELD

(IPPW-7)

## ABSTRACT

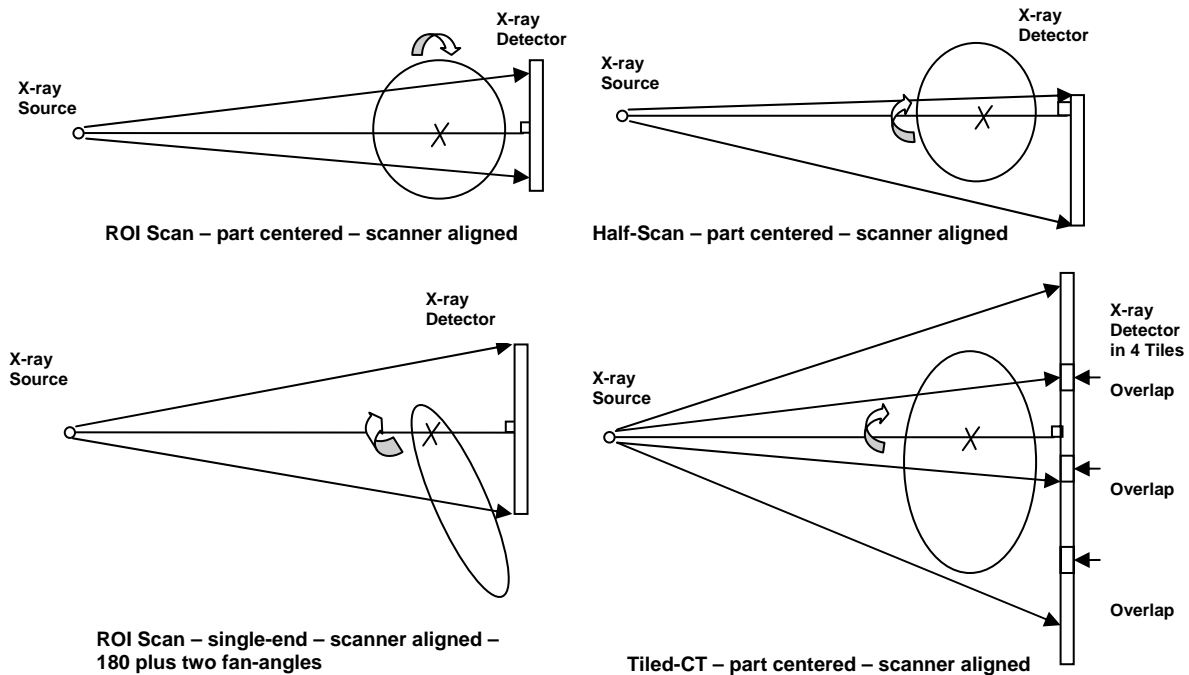
The 450 kVp scanning system at JSC includes motion can accommodate 4 different scanning modes. Figure 2 contains the different alternatives. Given the large size of the Stardust shield as compared to the 40 by 30 cm (approximately 16 by 12 in.) size of the Flashscan 33 detector, we elected to implement a ‘tiled-scan’ strategy. The impact of this choice is rather long scan times; the total scan time equals the time for a single scan multiplied by the number of tiles. Secondly, there is the added complexity of positioning the detector with sufficient precision to construct a “joined” scan that does not include artifacts from the “joining” operation. The source-detector geometry for the JSC 450 kVp room is cone-beam, requiring the detector be moved to cover the entire projected size of the Stardust shield at the detector plane. To reduce the number of tiles we elected to scan with “half-scan” or “offset-scan” techniques where we reconstruct the entire object from a field of view that covers just over half of the

Fig. 2 - Alternative scanning modes at JSC.

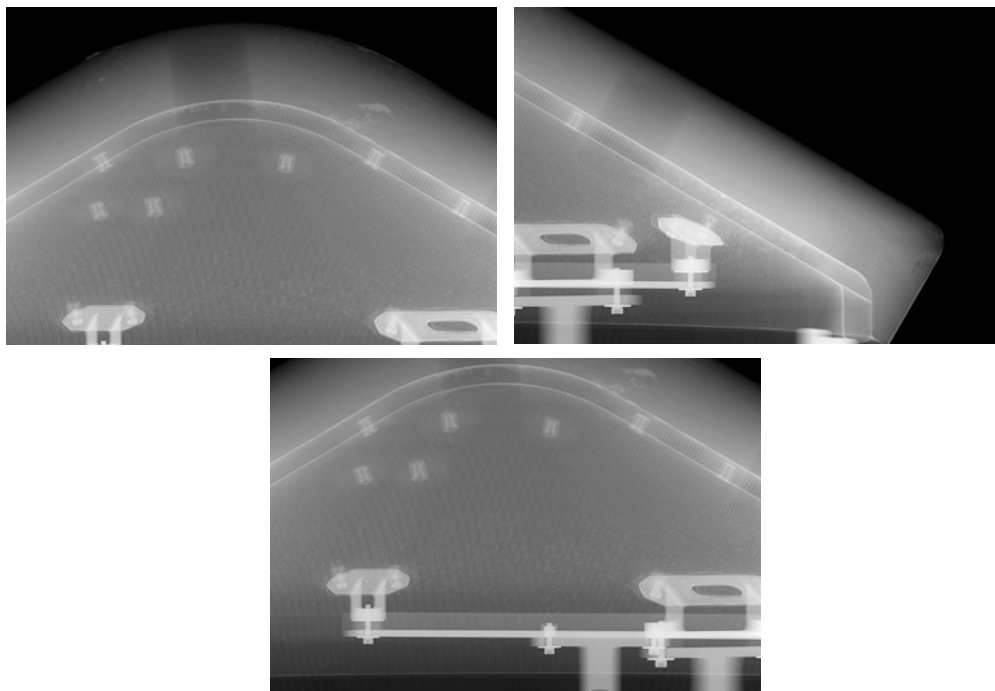
Fig. 3 - First images from the three acquired scans.

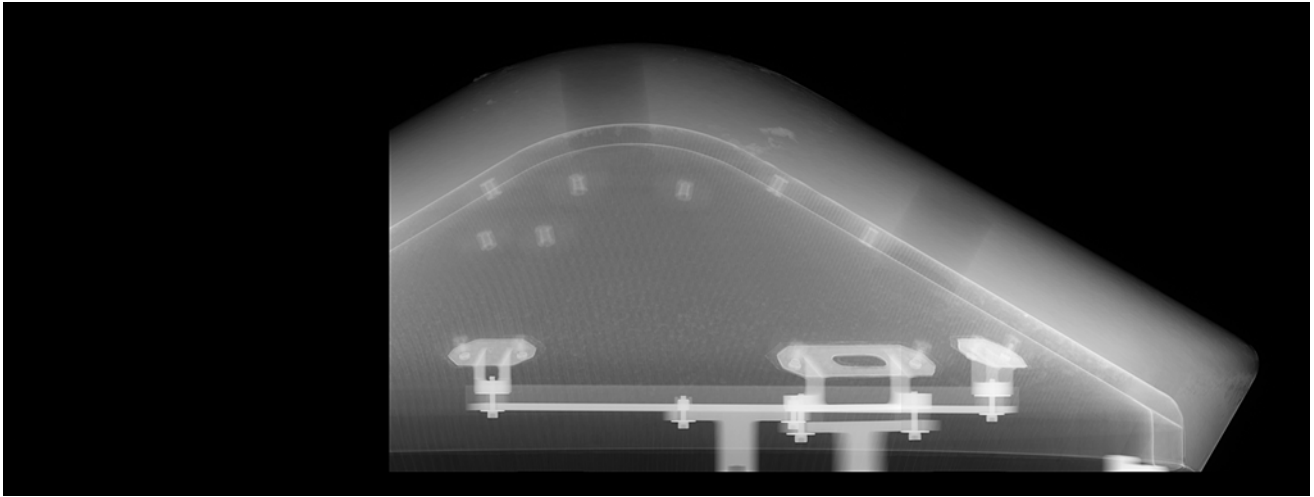
All 900 radiographs in the three tiles were joined into a radiograph as displayed in Fig. 4. Those 900 radiographs acquired over 360 degrees were then processed and reconstructed with a modified Feldkamp reconstruction algorithm for the “offset-scan” geometry illustrated by the radiograph in Fig. 5. In the course of processing the data we resampled the projection data to support a reconstruction into 0.324 mm cubic voxels (the 0.162 mm pixel radiographs were resampled 2x2). The result is a 2640 by 2640 by 1000 volume of voxel elements.

Fig. 4 - Joined digital radiograph from three tiled scans.

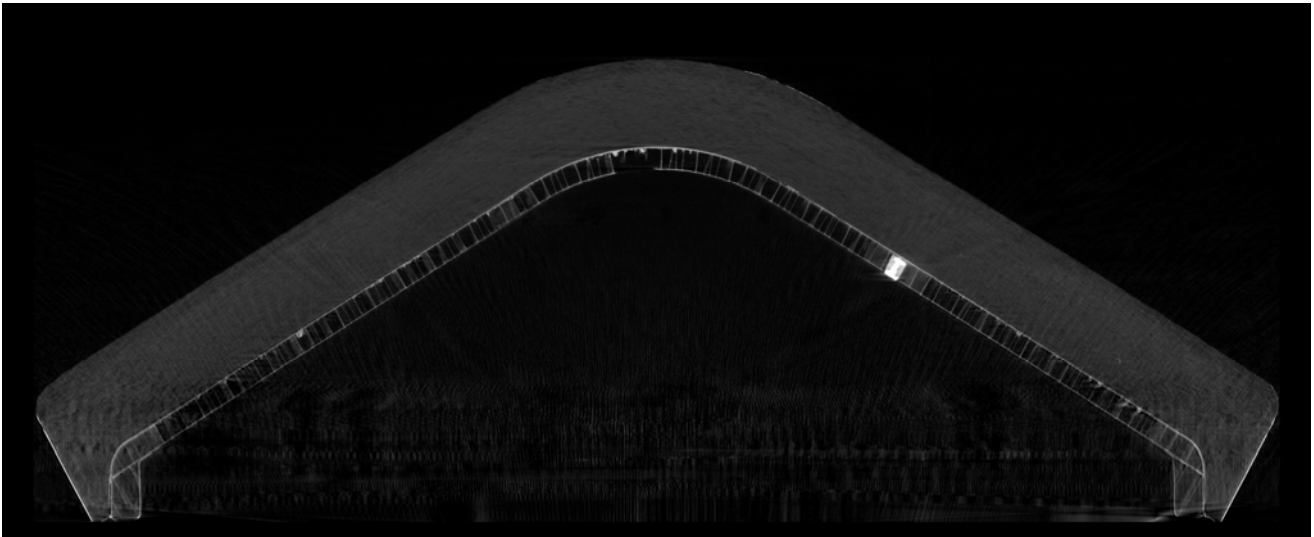
Fig. 5 - Vertical slice from tiled offset-scan.

The vertical slice shown in Fig. 5 shows two of the main components of the stardust shield, the PICA and the aluminum honeycomb underneath. Also, notice some structured noise or artifacts in the lower part of the vertical slice in Fig. 5 which are a combination of "streak" artifacts (from the long chords in the Aluminum and the inadequate number of views for a radiographic area of this size). Fig. 6 contains a close-up view of the center-top of the vertical slice from the reconstructed volume showing the type of detail imaged by the CT scanning in the JSC system. Using the different Aluminum pieces, and the drilled holes in the Stardust Shield as reference standards, the volume appears to include accurate dimensions of the internals of the Stardust shield.

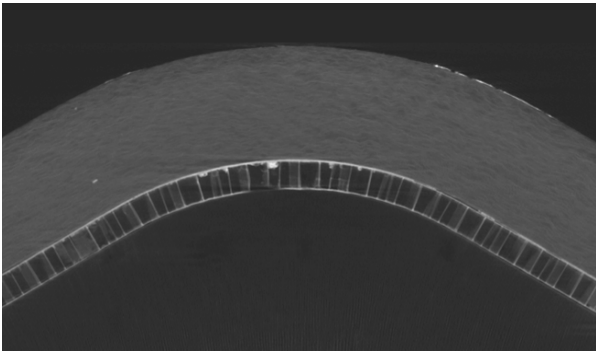
The 3D CT data can be viewed and unpacked in a number of different ways from a number of different orientations. Fig. 7 contains a cross-sectional or (transverse) slice through the Stardust reconstructed volume. In both Fig. 6 and Fig. 7, notice the texture in the slices through the PICA, we consider this texture in the images to be an accurate measure of the variation of the fibers in the make-up of the PICA. Also, there appears to be higher attenuating material sparsely interspersed within PICA material. Preliminary analysis of these higher-attenuating chunks indicate a close resemblance to the same features found in scans of recently fabricated PICA [1]. Second, notice the

small change in attenuation in the cross-sectional slices towards the outside boundary of the PICA, we consider this change in attenuation to be the char layer, a feature we will examine subsequently. Third, for the slices showing the state of the Aluminum honeycomb, notice a variation in the attenuation in the interstitial layer between the honeycomb and the PICA. It appears there are gaps in the fill between the PICA and the Aluminum honeycomb. Fourth, there appears to be higher attenuating material on the outside of the PICA. From a visual inspection of the outside of the shield, this is “dirt” accumulated on the shield from the landing. As expected the “dirt” is higher in x-ray attenuation than the PICA. Lastly, notice the hole cut

Fig. 6 - Extracted region from verticle CT slice.

in the PICA from some destructive analysis work. This feature provided a useful reference for verifying the dimensional accuracy of our reconstructed volume.

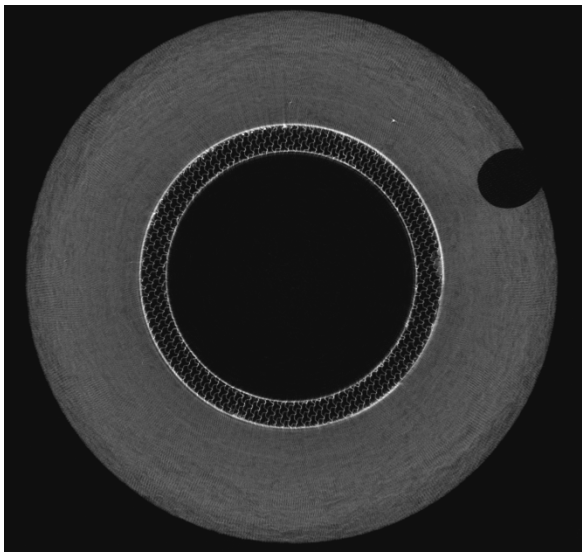
Fig. 7 - Transverse CT slice.

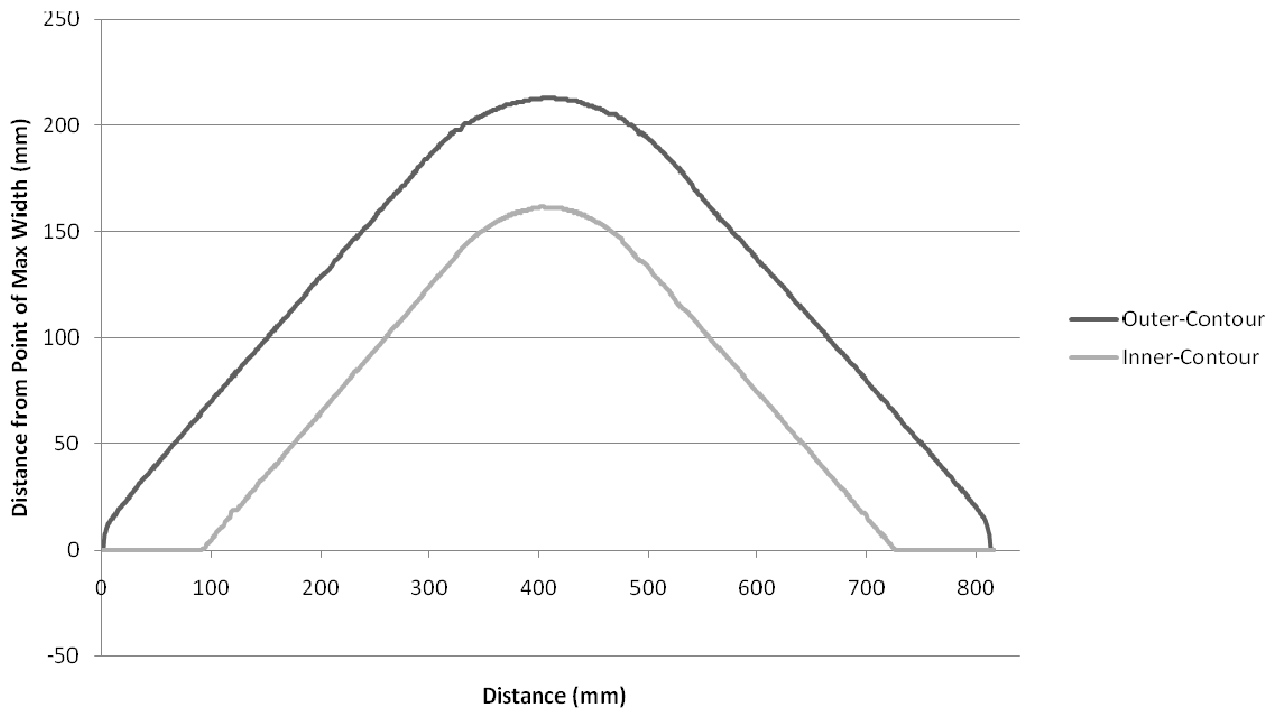
The measurement procedure for a center vertical slice involves three steps; 1) measure the coordinates of the boundary of the outer PICA layer from the center vertical slice, 2) for the same vertical slice, measure the boundary of the inner PICA layer (the inner boundary is bounded by the aluminum honeycomb layer), and 3) measure the distance from outer to inner boundary on the line perpendicular to the surface of the outer boundary. Fig. 8 shows plots of the outer and inner boundary contours of the PICA layer from the scan of the Stardust shield obtained from “shrink-wrap” operations applied to the volume. Fig. 9 shows the PICA thickness measured from the boundaries in Fig. 8 compared with the “as-built” thickness. Fig. 10 shows the estimated material loss based on Figs. 8 and 9.

Fig. 8 – Plot of inner and outer boundaries of PICA.

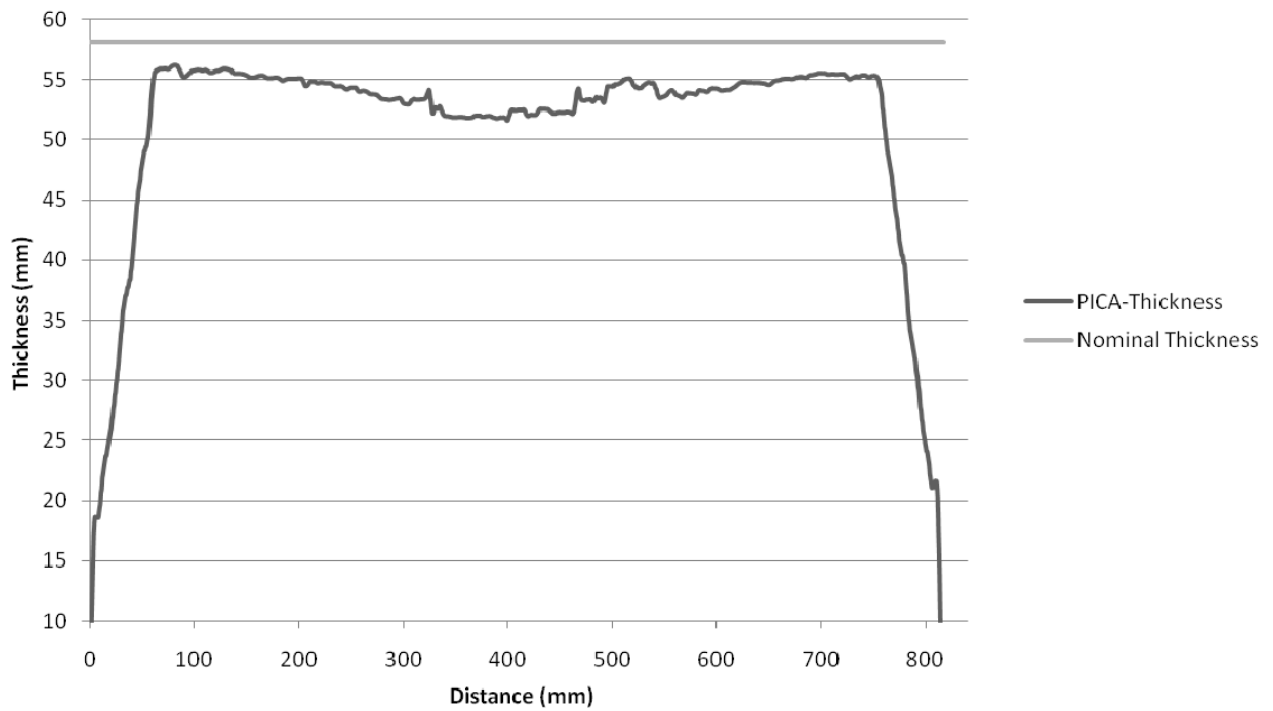
Fig. 9 – PICA thickness measurements.

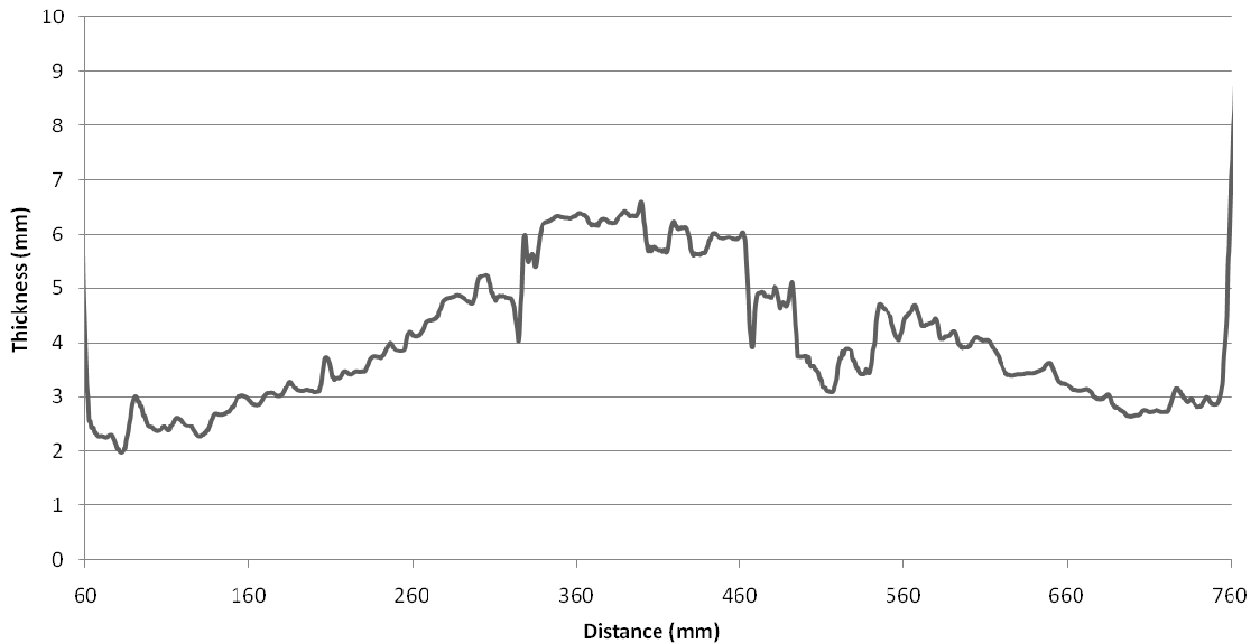
A few trends in the material loss in the PICA are apparent from the data. First the loss of material (compared to the assumed build with a constant thickness) is greater at the top of shield than towards the outer ends. The maximum loss is around 6.3 mm (¼ inch) in thickness. But as can be seen from the outside of the shield there is substantial variation in the outer texture with “chunks” of the shield missing, possible due to the impact at landing. However, independent of the chunks missing from the shield, there appears to be a near-linear decrease in the loss of the PICA material proceeding from the top of the Shield to the outside edges.

Fig. 10 - PICA thickness loss from nominal thickness of 58 mm.

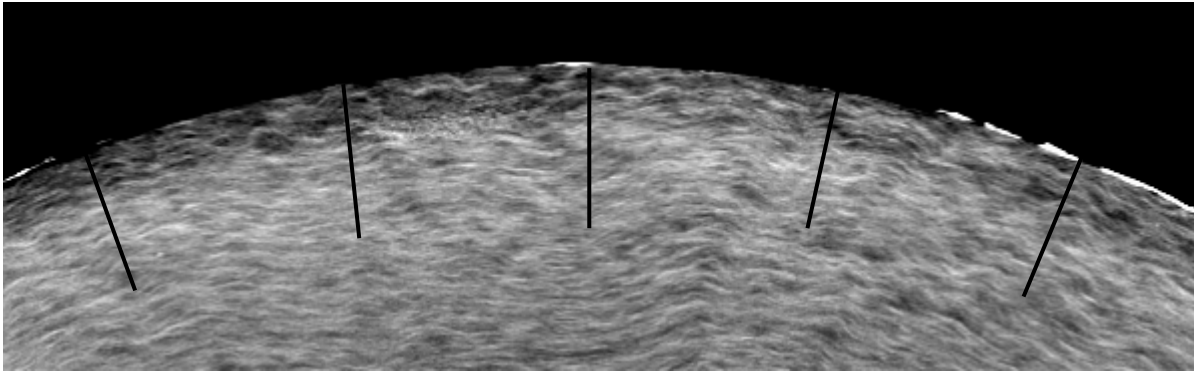
The “char” layer is a lower attenuating band of PICA material at the outer boundary of the shield. Fig. 11 includes an image extracted from the top of the dome, with the grey-level-window set to just span the attenuation of the PICA (the “dirt” on the outside layer are all at the maximum gray level). Notice the subtle differences in density characteristic of this layer. To

Fig. 11 - Extracted section of top dome showing approximate positions of line-outs.

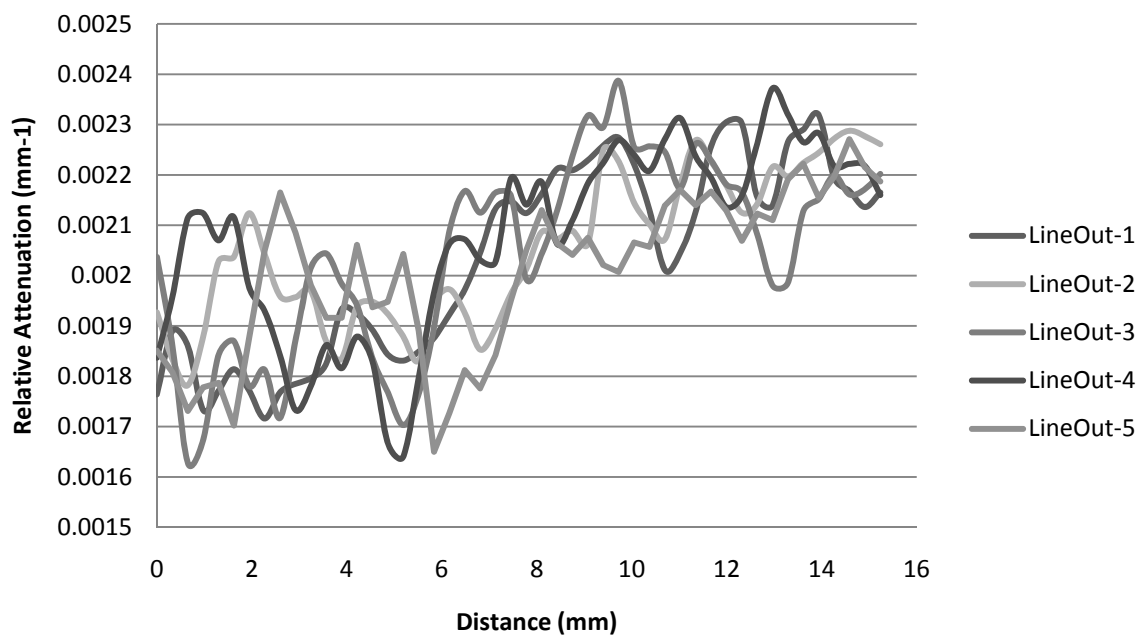
obtain a quantitative measure of the density differences in the charred PICA line-outs were acquired at different positions indicated on the image. Fig. 12 is a comparison of the relative attenuation along the line outs. Since the char layer occupies the region close to the outside boundary, we obtained “shell-extractions” from the reconstructed volume. This process involves finding the outer boundary, then shrinking the outer boundary to intersect a layer at a uniform distance from the edge, thereby generating an image of the internals of the Stardust shield in exclusively in the char layer. Fig. 13 is an image of the shell extraction of the entire char layer, Fig. 14 is a extract of the char layer shell, and Fig. 15 is an extract of a layer deeper into the PICA.

Fig. 12 - A comparison of the relative attenuation from the line-outs indicated in Fig. 11.

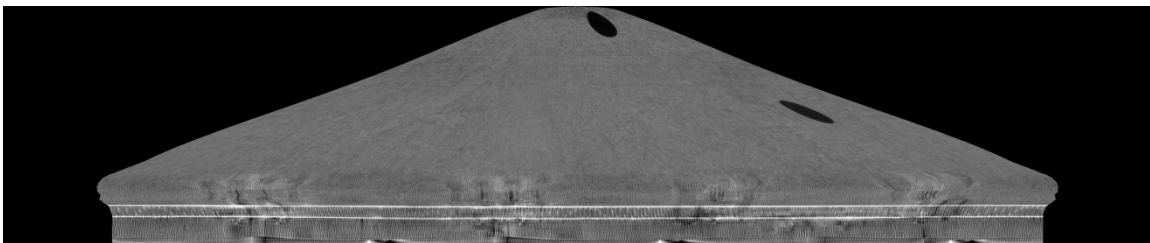
Fig. 13 - Shell extraction for the entire volume in the outer char layer.

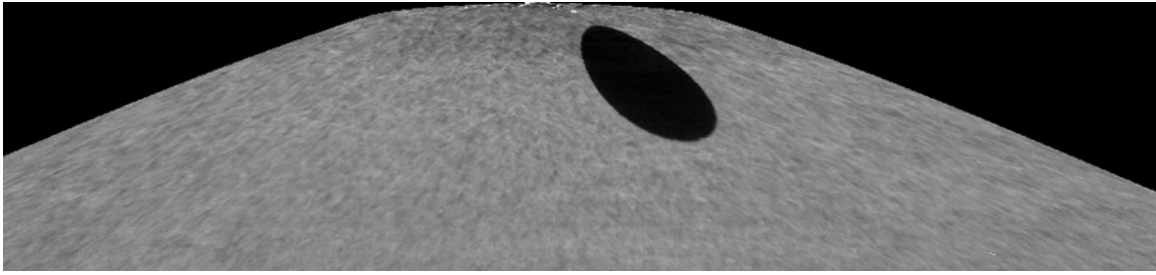
Fig. 14 – Extracted region from the shell of the outer char layer.

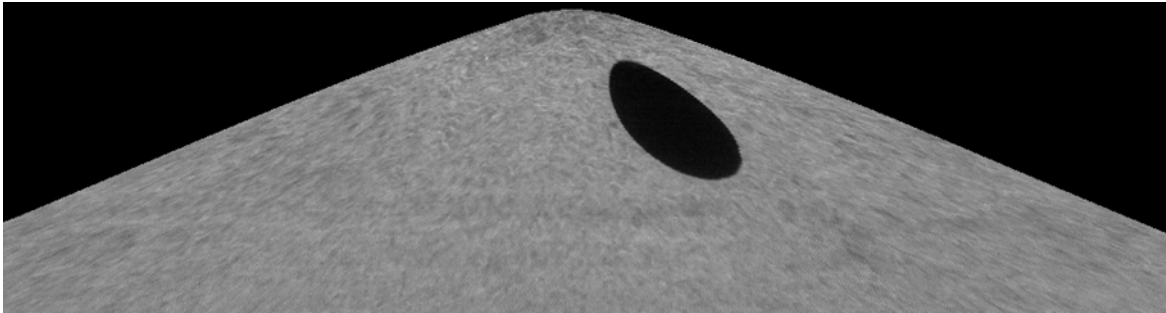
Fig. 15 - Extracted region from the shell of the inner layers of PICA well inside the char layer.

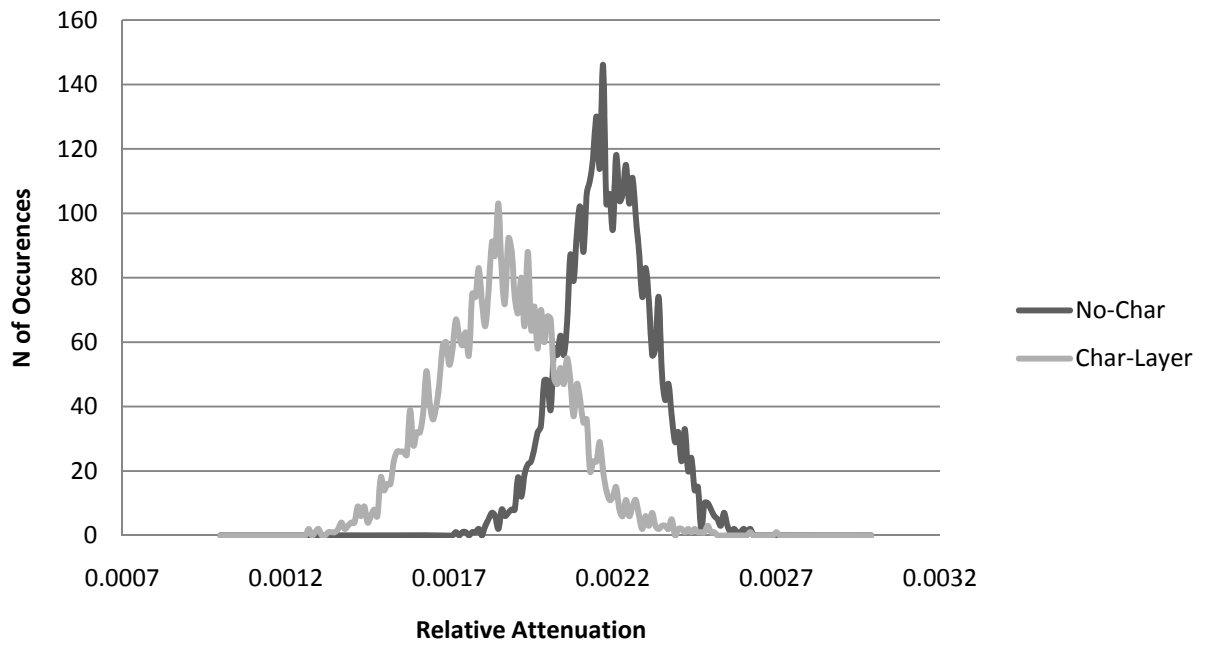
Fig. 16 - Histograms from extracted regions of the same size from the shell extraction data.

Third, and as expected, the loss in density in the char layer results in a material that is less uniform than the “no-char” region as shown in the width of the histogram for the “Char-Layer” voxels.

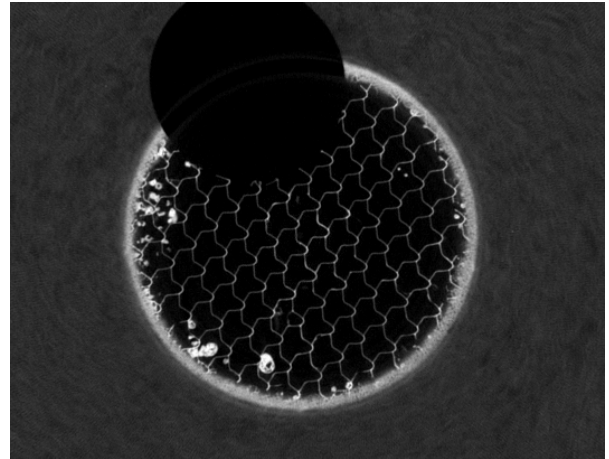
The “bond-layer” referred to here is the layer of material in-between the PICA and the Aluminum honeycomb. From the cross-sectional slices presented above and below the layer is higher in attenuation than the PICA, and is close in attenuation to the Aluminum. Figure Figs. 17 and 18 contain extracted regions from cross-sectional slices through the PICA, the section at the top of the honeycomb and containing the bond-layer. Notice the small porosity at about 4 o'clock in the bond-layer in Fig. 17. Also, notice the excess metal in the honeycomb.

Fig. 17 - Cross-sectional slice showing PICA, bond-layer and Honeycomb.

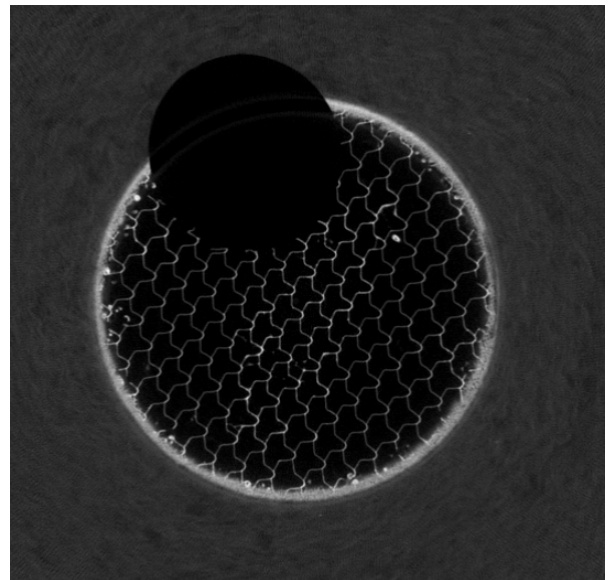
The cross-sectional slice in Figure 18 shows a gap in the bond-layer at a radial position of 3 o'clock. This void-space in the “bond-layer” extends a length of approximately 20 mm at this particular position.

Fig. 18 - Cross-sectional slice showing a gap in the bond-layer.

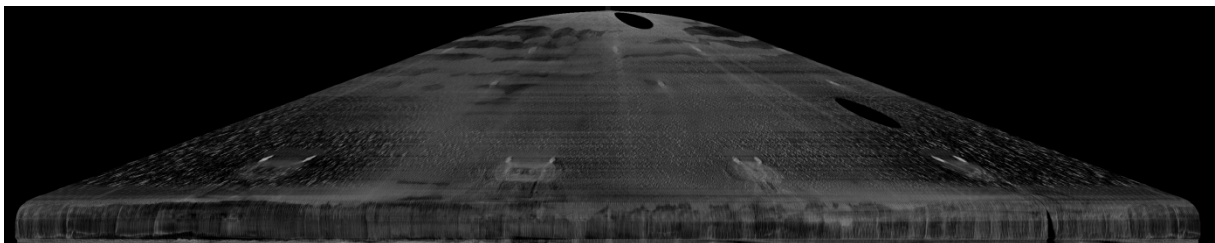
Fig. 19 - Shell extraction of the bond-layer.

“Shell extractions” utilized above to examine the char layer can be used to evaluate the bond-layer in the Stardust heat shield. Using the exterior of the aluminum honeycomb as a boundary we can position a shell with this contour in the geometric position of the “bond-layer”. Consequently, we obtain an image of the entire “bond-layer” in one image. Figs. 19 and 20 show this.

The “shell-extraction” images show a number of gaps in the “bond-layer” in the Stardust heat shield. In general the bond-line is better filled at the top of the shield than down the length towards the ends of the shield. In particular for the section at the top shown in Fig. 20 the bond-layer is only 62% filled, that is 38% of the space in the bond layer contains substantial voids. At this point in time these results have not been compared to the as-built data so it is not clear if the void-fraction developed over time in service, or the void-fraction is as-built

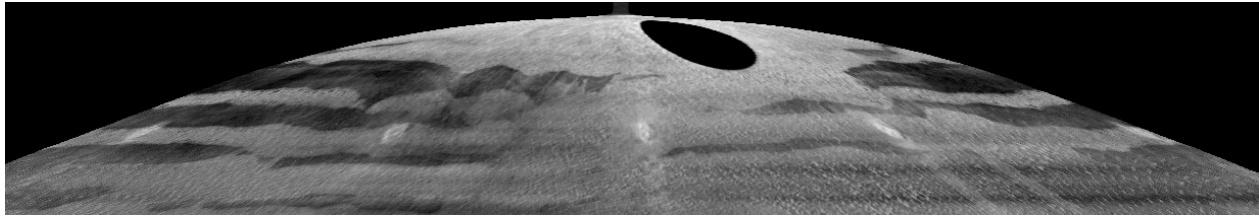
Fig. 20 - Close-up of the top of the image in Fig. 19.

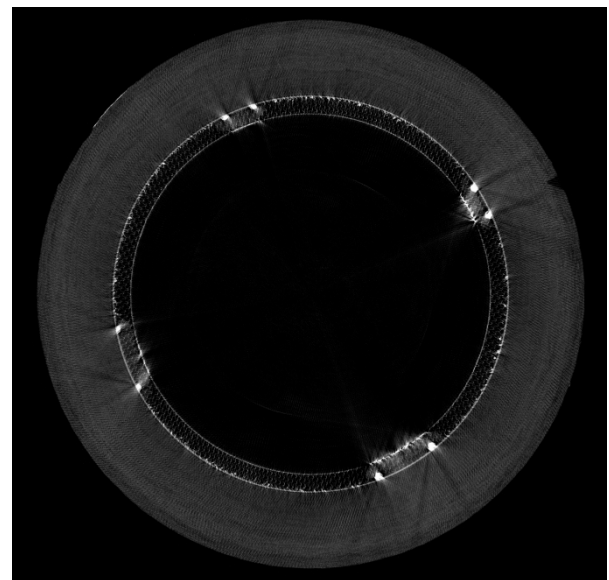
From the evaluation of the entire 3D CT volume two different types of artifacts can be identified which hamper the evaluation of certain features in the data. First, the sections of PICA and aluminum honeycomb in close proximity to the Aluminum support structure are inundated with troublesome “streak” artifacts. Fig. 21 contains a cross-sectional slice displaying these effects in the reconstructed volume. These artifacts are the result of a “lack of penetration” of the longer sections of Aluminum in the support structure combined with the proportion of “Background Scatter” [3] characteristic of this technique. In many cases these effects can be remediated by a thicker x-ray beam filter, thereby increasing the average energy used in the scanning. This should be considered in subsequent scanning.

Fig. 21 - Cross-sectional slice showing streak artifacts.
