COMET NUCLEUS TOUR

MISHAP INVESTIGATION BOARD REPORT May 31, 2003

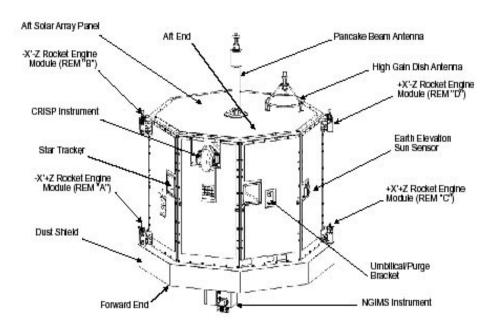
The spacecraft body (Fig. 1) was an aluminum octagon with solar cells mounted on the sides and back. The spacecraft had multilayer dust protection to survive the expected impact environments at the comet targets. The dust shield, built of multiple layers of Nextel® with a Kevlar® backstop, protected the forward end of the spacecraft, except where the solid rocket motor (SRM) nozzle protruded through the dust shield.

Figure 1. The CONTOUR spacecraft.
